# THE RUGER® M77 RIFLE

## PRODUCT SAFETY WARNING AND RECALL NOTICE

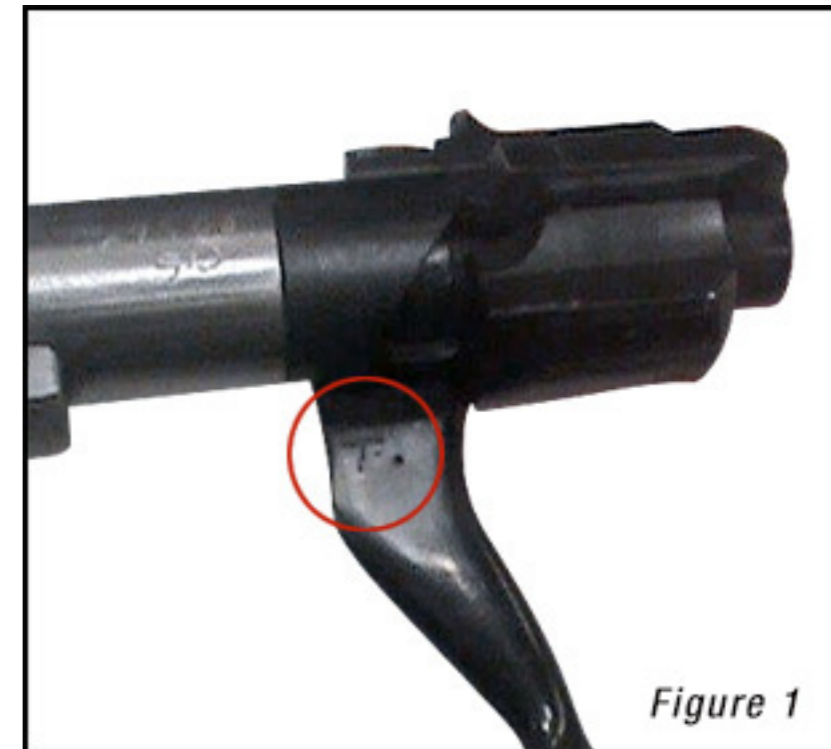
Figure 1

Ruger® M77® bolt action rifles produced in later years have the set screw permanently secured. These rifles have a "T" inscribed on the underside of the bolt handle (see Figure 1). For your safety, we ask that all owners of the M77® rifles (except those with a "T" underneath the bolt handle) contact us for a new locking screw to replace your present overtravel adjustments set screw.
